Manhole Inspection Summary

Manhole # S08AA2017MH

Location Address: **6934 REISTERSTOWN RD**

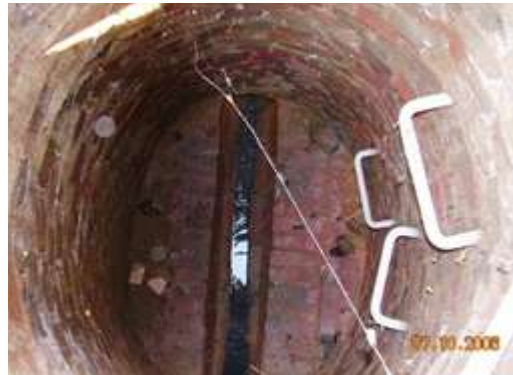
Top View

Adjustment infiltration. Bench debris.

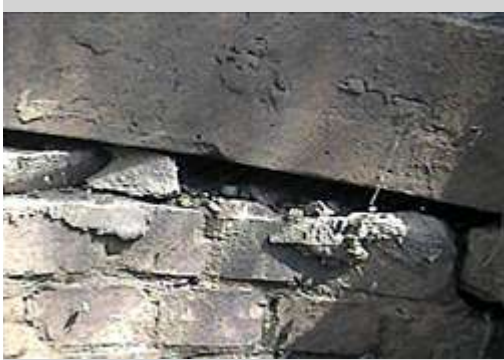
Defect

Frame leaks. Adjustment deterioration, loose brick, and infiltration.

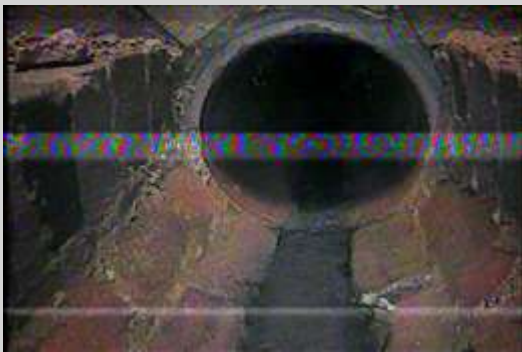
8 in. Circular Gravity Sewer Pipe Out @ 12 O'Clock

Infiltration: **Evidence** Pipe Seal Cond: **Cracked**

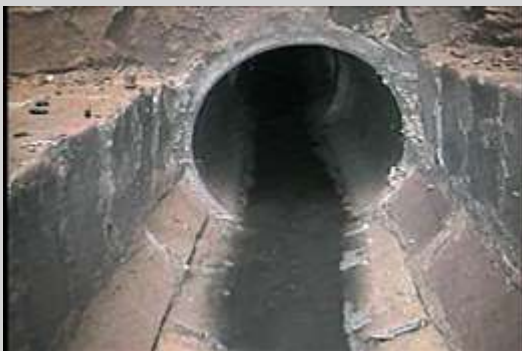
8 in. Circular Gravity Sewer Pipe In @ 6 O'Clock

Deposits: ☐ None ☒ **Mud** ☒ **Grassy** ☐ Debris ☐ Grease

Silt Depth: **0** (in.) Deposits Extent: **Light**

Infiltration: **Evidence** Pipe Seal Cond: **Unknown**
